AFFIDAVIT OF TOM MOORE

INSPECTION REPORT 8-12-02

An inspection was done on August 12, 2002 at a residential property at 354 Timber Road, Mt. Gretna, PA. The purpose of the inspection was to examine the house for moisture and water problems that possibly may have contributed to a mold and mildew condition resulting in the occupants having to move out of the house.

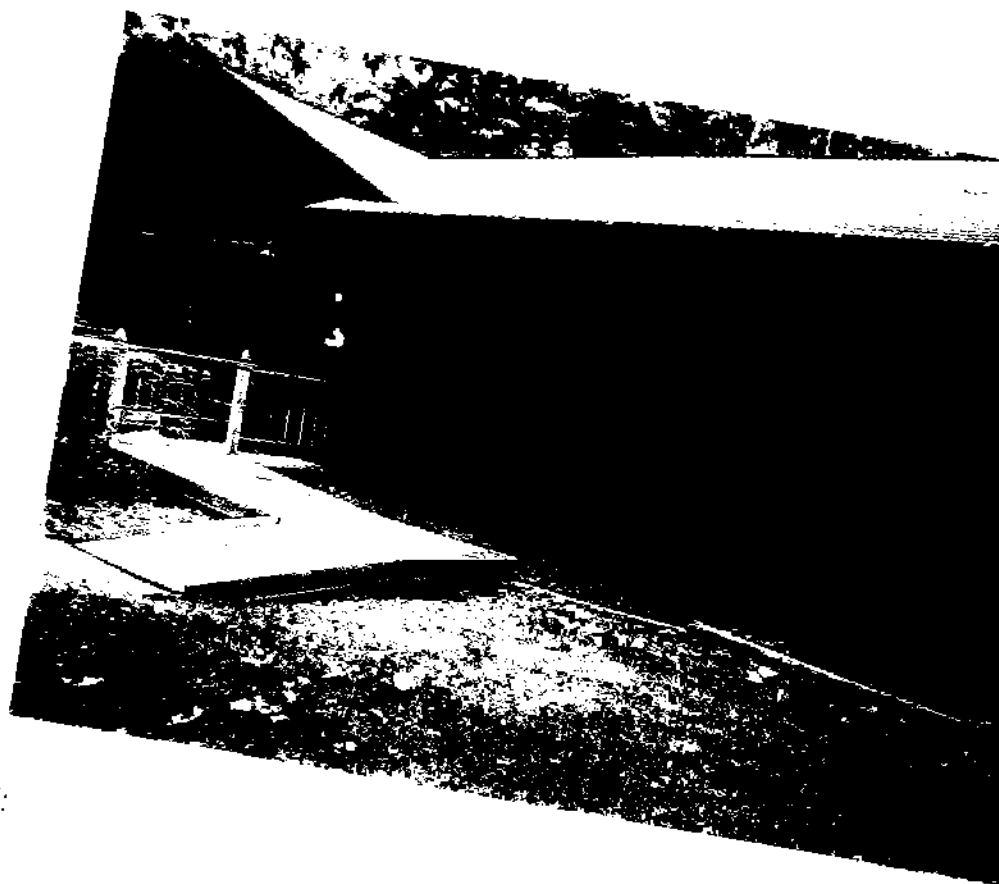
Photo # 5:

The house is a single story ranch style house with a full basement and integral garage underneath. The exterior and grounds inspection found some low areas and negative slope at the front and sides. (photos 5,7,8,9,10) The ground should be graded to slope away from the house so surface water is diverted. The gutters were found to have leaves and debris in them and they need to be cleaned out. The front center downspout had black corrugated piping attached to it to carry the discharge water around the side and to the rear of the house. (photo 4) The driveway slopes toward the garage and has inadequate drainage in front of the door. (photo 15,16) There was evidence of water entering under the garage door and path way into the garage. (photo 29) Proper drainage needs to be installed to handle all rain conditions. The right rear downspout was smashed almost closed and needs to be repaired.
